Cadenza Innovation

UN Battery Testing

TEST REPORT

MGA REPORT NO.: C18T1-237
TESTS PERFORMED ON: October 10 - November 12, 2018
TEST DESCRIPTION: UN Battery Testing
ITEM DESCRIPTION*: Lithium-Ion Prismatic Cells
PROCEDURE NUMBER: TP022-10

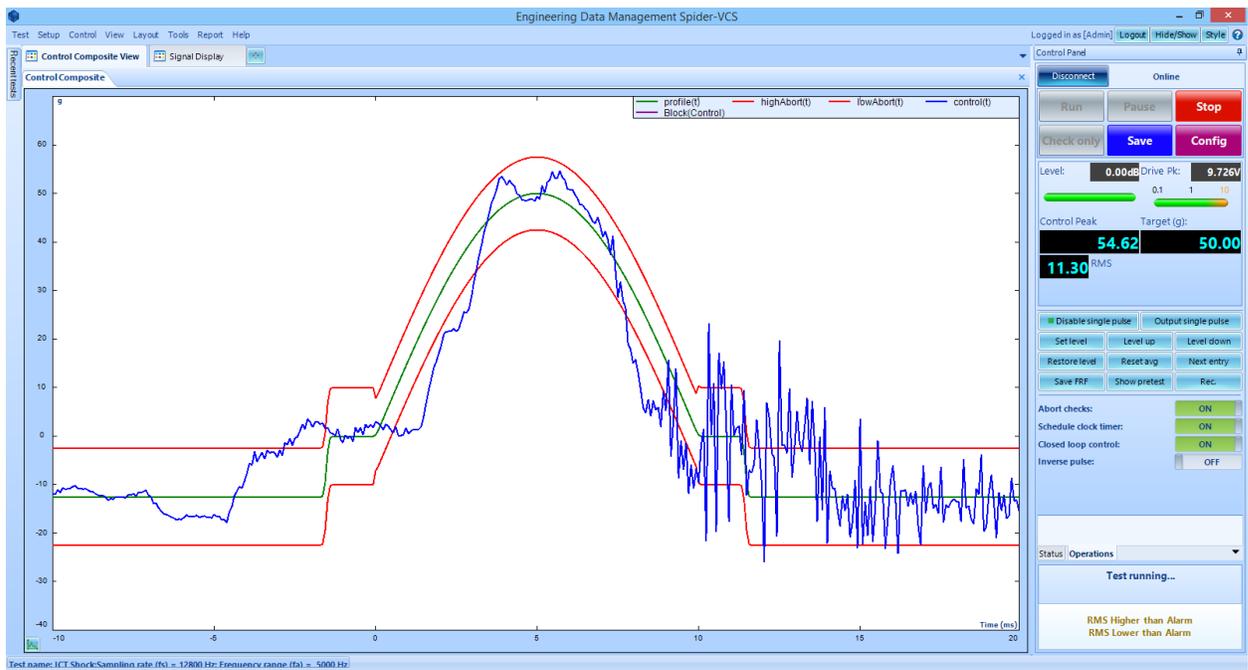
T4 Mechanical (+) Lateral Run 1 Units: 3129, 3130, 3165, 3166, 3167

Ten (10) lithium-ion prismatic cells were fastened to a drop tower and subjected to a half sine shock with a peak acceleration of 50g and pulse duration of eleven (11) milliseconds. The units under test received three (3) shocks in the positive and negative directions in each of the three (3) orthogonal axes for a total of eighteen (18) shocks.

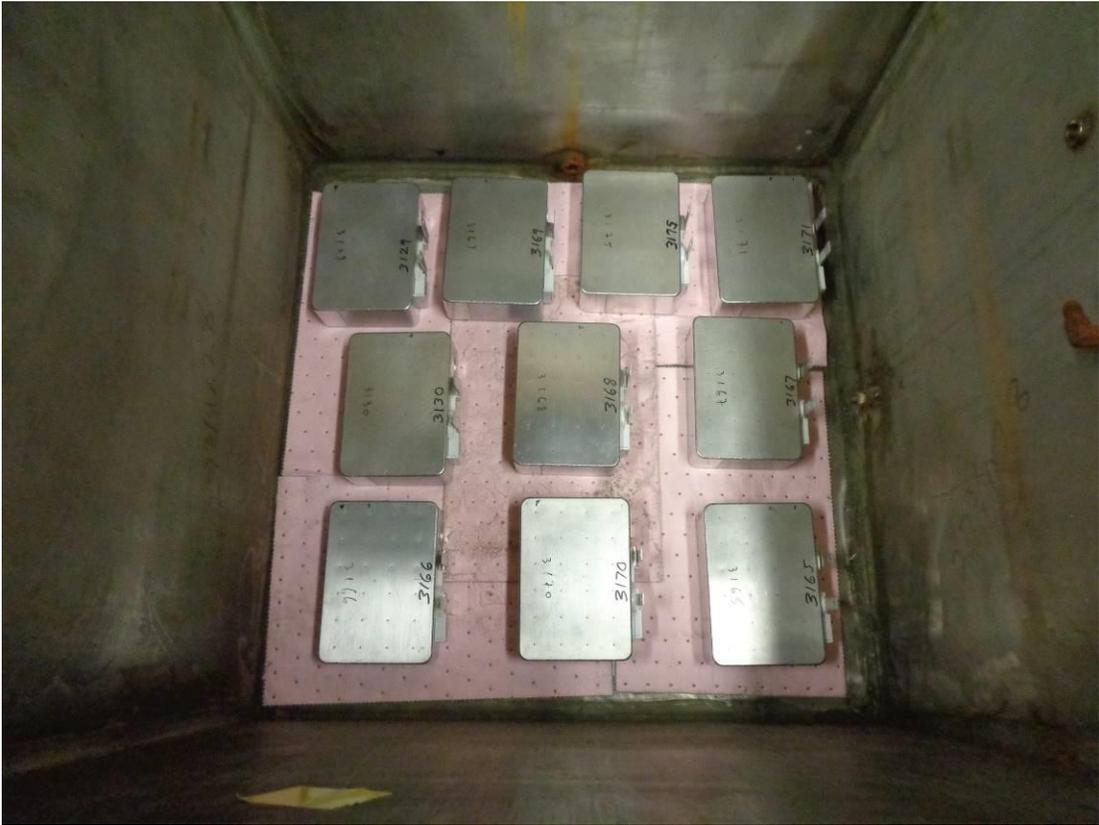
T1 Altitude

Ten (10) lithium-ion prismatic cells, were at a pressure of less than 11.6 kPa for a minimum of six (6) hours at ambient temperature (20 ± 5 °C).

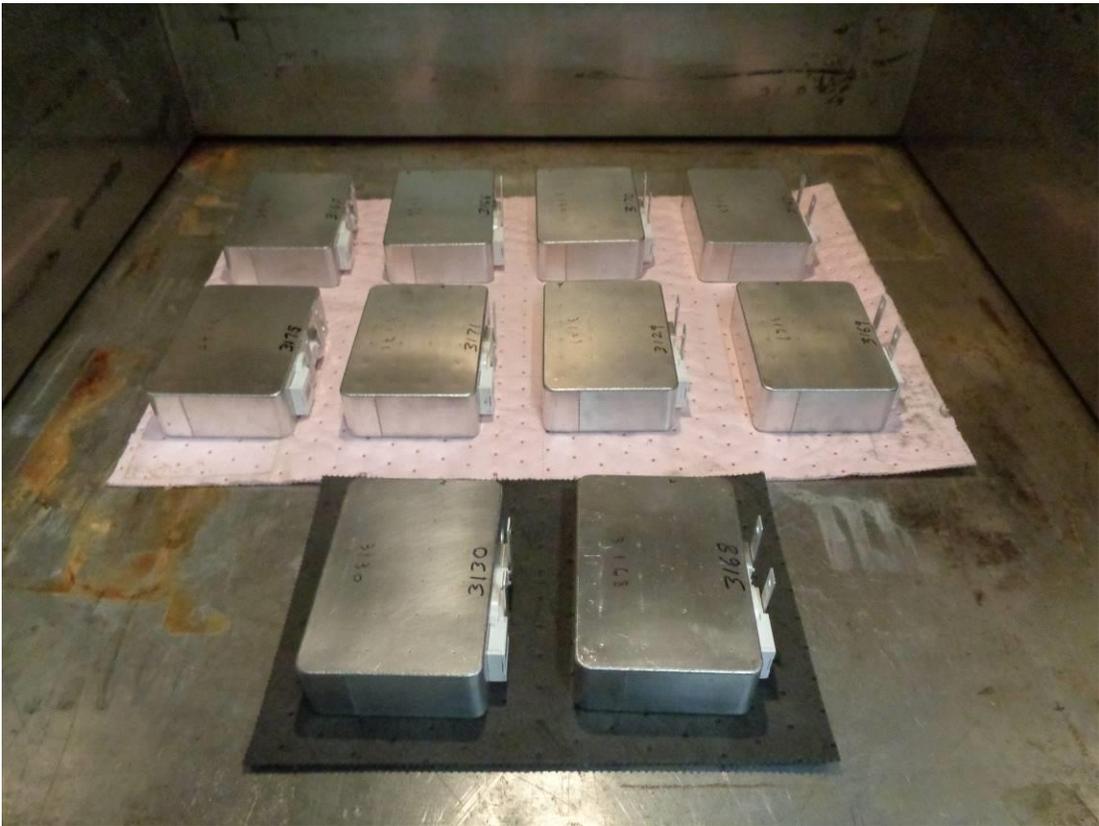
T2 Thermal

Ten (10) lithium-ion prismatic cells were stored for at least six (6) hours at a temperature of 72 ± 2 °C, followed by at least six (6) hours at a temperature of -40 ± 2 °C. The maximum rate of temperature change was thirty (30) minutes. This sequence was repeated ten (10) times. The modules were then stored for twenty-four (24) hours at ambient temperature (20 ± 5 °C).

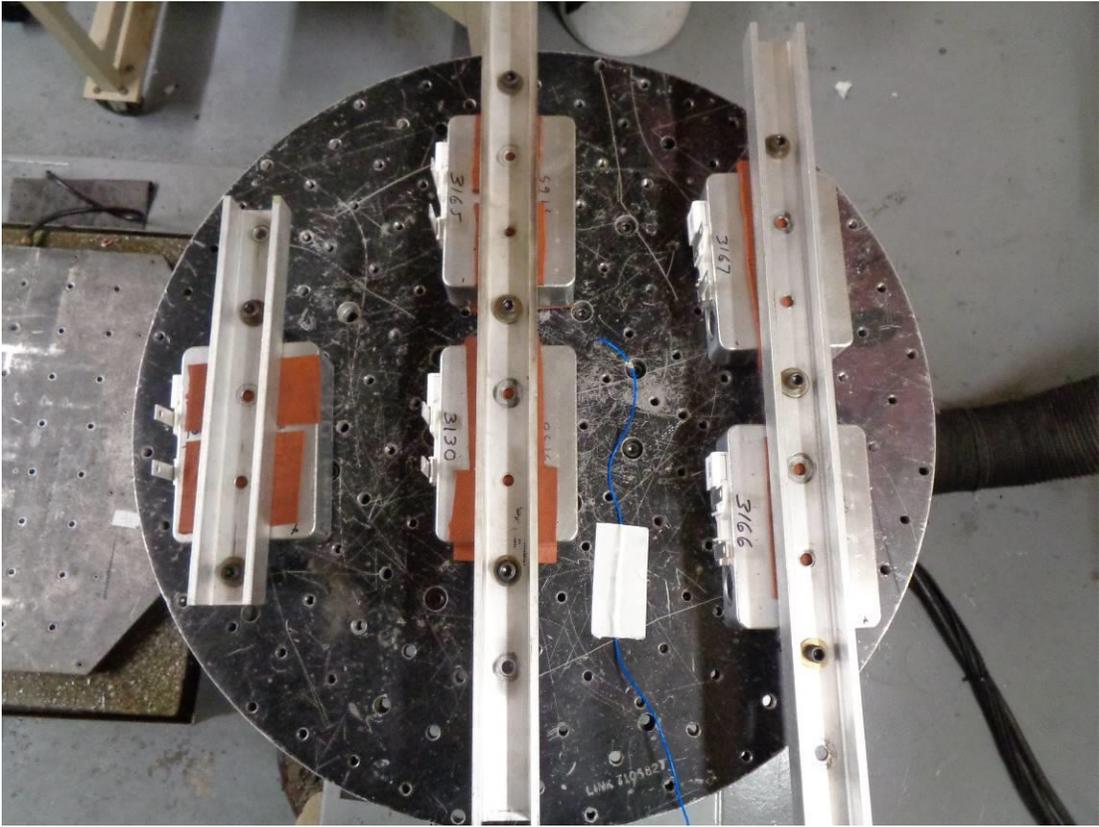
T3 Vibration Lateral

Ten (10) lithium-ion prismatic cells were fastened to an electrodynamic shaker and subjected to a sinusoidal sweep between 7 Hz and 200 Hz and back to 7 Hz, traversed in fifteen (15) minutes. This cycle was repeated twelve (12) times for a total of three (3) hours in each of the three mutually perpendicular axes.

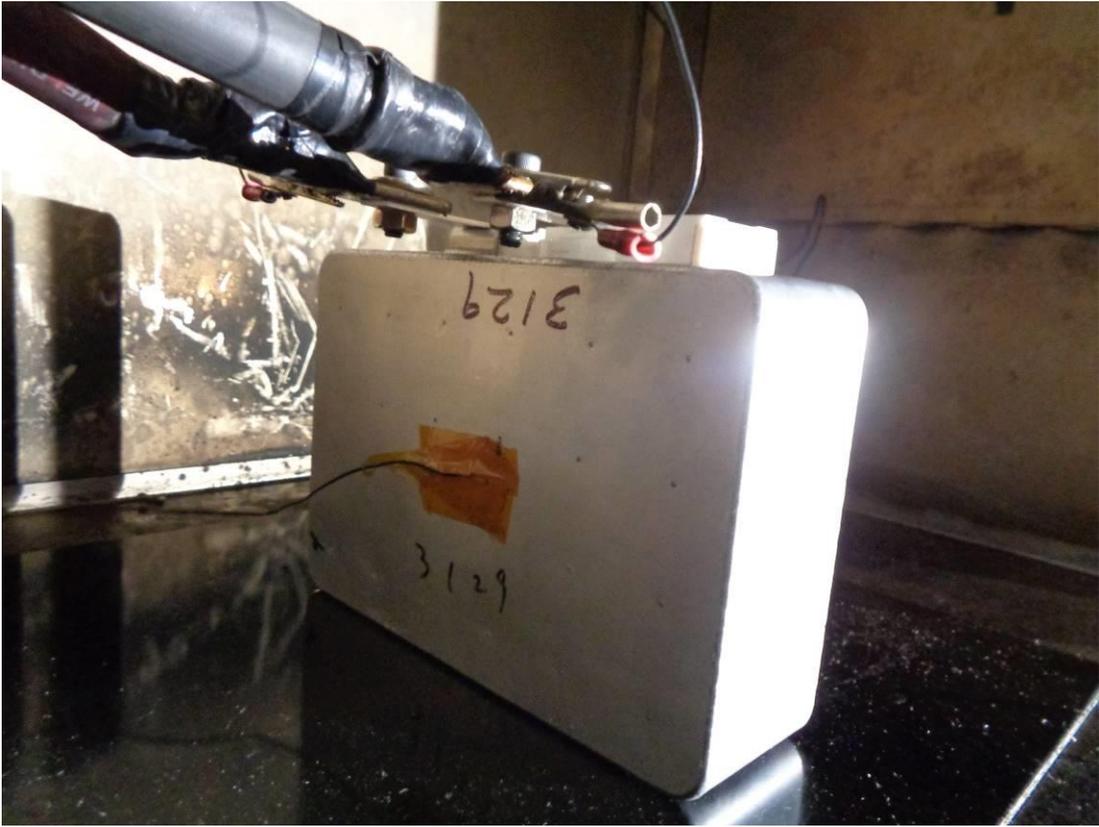
T5 Short Circuit

Ten (10) lithium-ion prismatic cells external case temperatures were stabilized at 57 ± 4 °C, before being subjected to a short circuit condition with a total external resistance of less than 2 milliohms, measured prior to testing at 1.58 milliohms. After the case temperatures returned to 57 ± 4 °C, the short circuit continued for an hour. After an additional six (6) hours of observation, the testing was concluded.

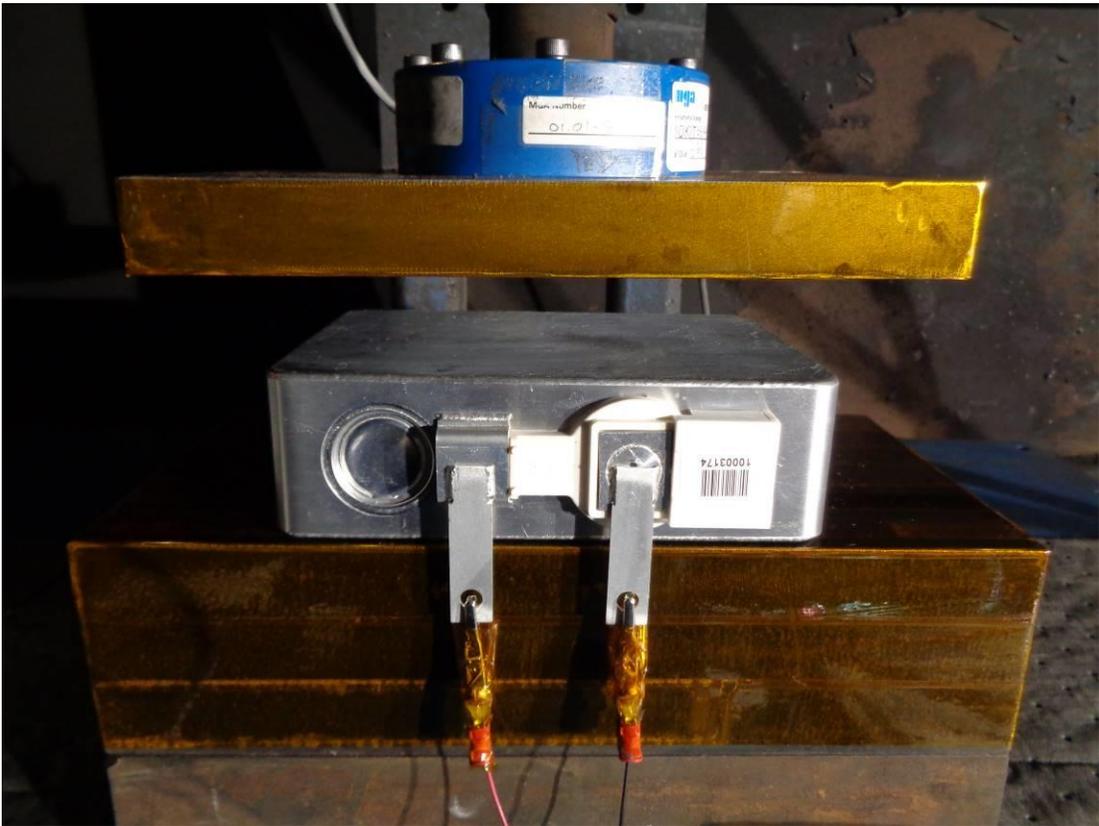
T6 Crush

Five (5) lithium-ion prismatic cells were crushed between two flat surfaces. Crushing was performed gradually at a speed of approximately 1.5 cm/s at the first point of contact and was continued until one of the following end points was reached:

- a) The applied force reached $13 \text{ kN} \pm 0.78 \text{ kN}$.
- b) The voltage of the cell dropped by at least 100 mV.
- c) The cell was deformed by 50% or more of its original thickness.

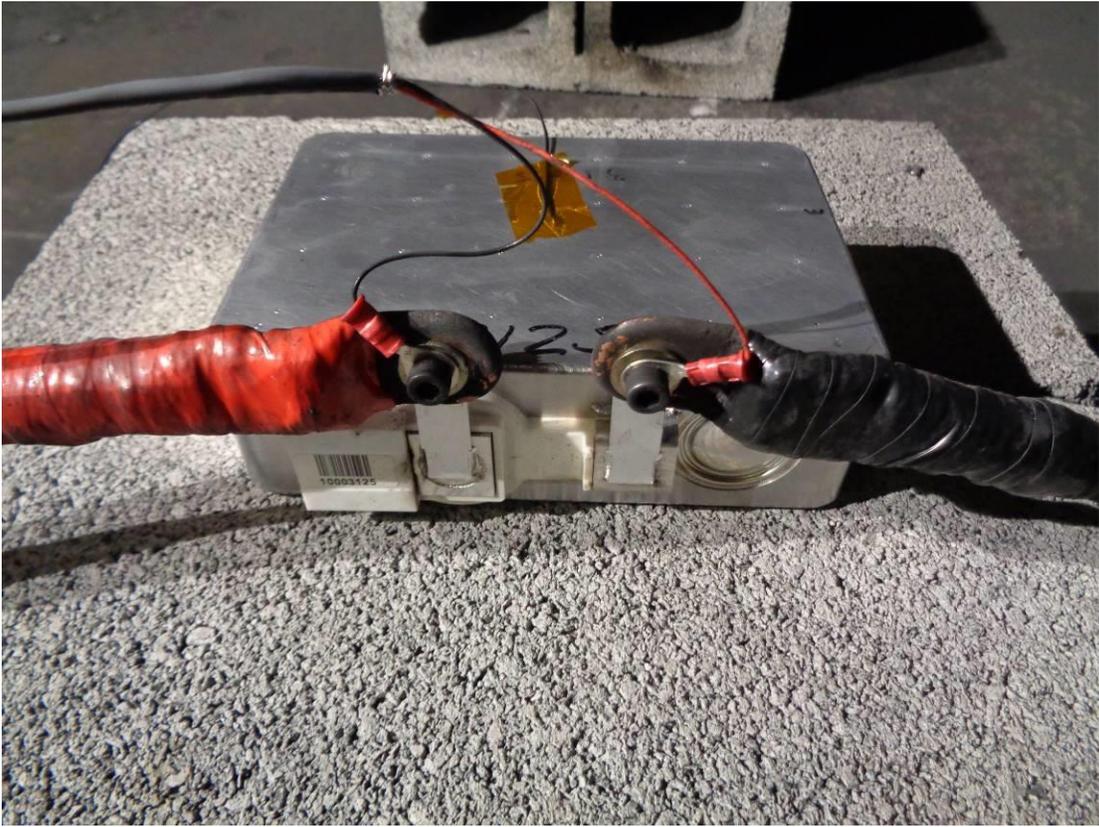
T8 Forced Discharge

Twenty (20) lithium-ion prismatic cells were forcefully discharged at ambient temperature by connecting them in series with a 12 Volt D.C. power supply at an initial current equal to the maximum discharge current as specified by the manufacturer: 166A. Each cell was forcefully discharged for a time interval (in hours) equal to its rated capacity divided by the initial test current (in Amperes): 0.5 hours.
